**ODESSA DAM
LAFAYETTE COUNTY, MISSOURI
MO. 20042**

PHASE 1 INSPECTION REPORT NATIONAL DAM SAFETY PROGRAM

ODESSA LAKE DAM
LAFAYETTE COUNTY, MISSOURI

MISSOURI INVENTORY NO. 20042

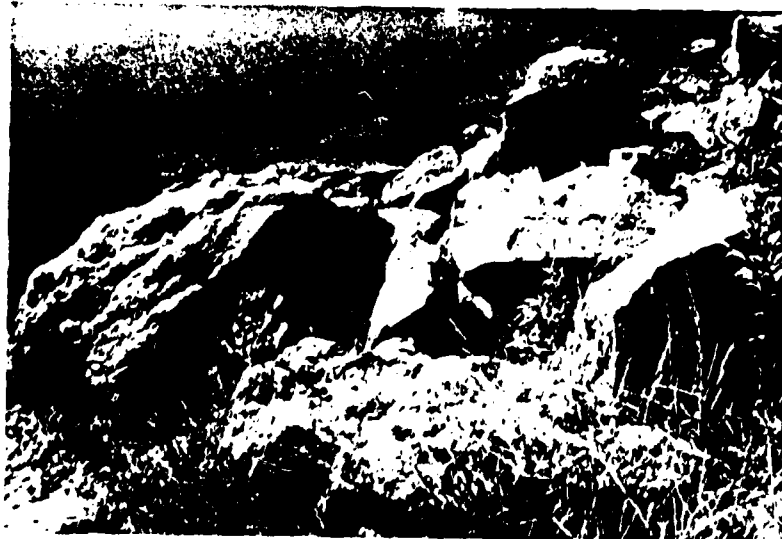
Photo No. 3: RIPRAP ON UPSTREAM FACE
